1. PURPOSE AND SCOPE OF THIS MEMORANDUM

This memorandum summarizes a site survey performed on July 18, 2008 to evaluate the condition of ADA-mandated accessibility at the Library in Pembroke Massachusetts. After a description of the site and interior conditions of the building, recommended improvements are provided in Section 7, beginning on page 6.

The subject property is the Pembroke Public Library at 142 Center Street.

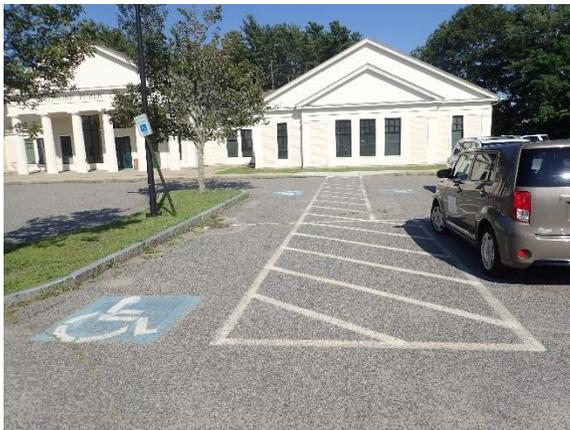
The Library is marked by a free-standing yard sign at the driveway entrance and a single sign above the main building entrance, both visible from Center Street. The parking areas in front of the building and at the South side are paved and contains approximately 59 marked parking spaces,

5 of which are designated as accessible. Signage for these spaces is inconsistent and typically is not provided at the centerline, head-on position. There is no marked van-accessible space, although at least one of the marked spaces and its access aisle appear to meet the required dimensions.

7. SHORT TERM SITE IMPROVEMENTS
 - a. Accessible Parking
 - i. Re-stripe and designate van-accessible space and access aisle. Provide required signage.

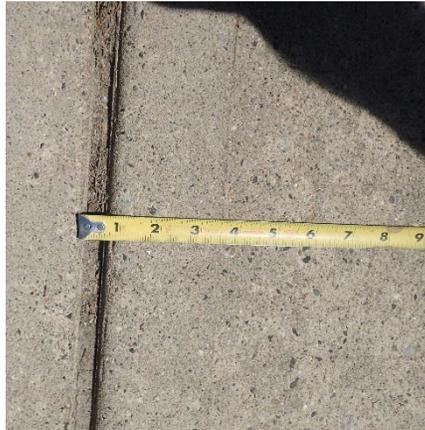
Some of the accessible and standard parking spaces noted above may be shared by users of the adjacent Community Center to the West. The condition of accessible parking spaces and the accessible route to the building entrance is generally good. Minor differential settlement of

concrete paving was noted near the main entrance, where a gap in excess of the ADA maximum ½" was noted.

Parking area and accessible route are in generally good condition, but spaces lack some or all required signage. A van-accessible space is not identified.
 - ii. Ramps and doors
Minor differential settlement of concrete sidewall sections.
 - iii. Signage and service locations
Signage is generally compliant.
 - iv. Restroom facilities
No barriers noted.

8. LONG TERM SITE IMPROVEMENTS
 - a. Along accessible path to main entrance, install high-density joint filler at gaps between sections of paving, wherever gaps exceed ½" horizontally. Fill or grind adjacent surfaces where vertical steps exceed ½".

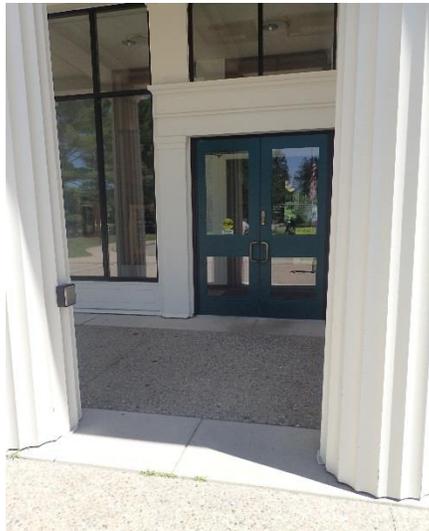
The main entrance is accessible, and is provided with a power door operator.

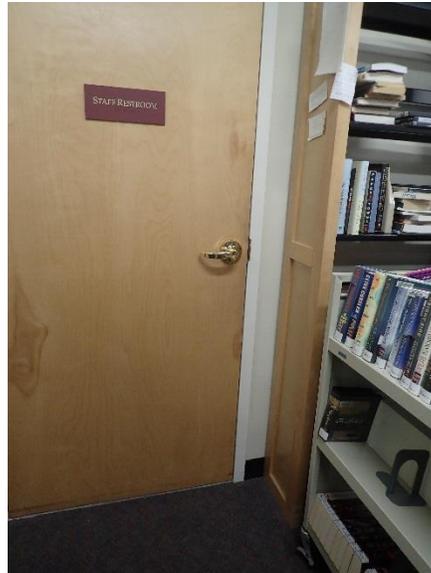
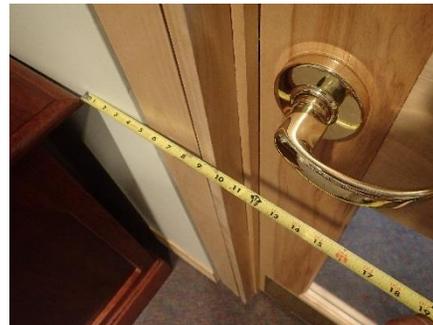
- Lack of adequate side clearance at doors. A minimum 18" clearance is required at the latch-pull side of any passage or entry door. This is typically the result of furniture placed too close to the door; the necessary clearance is generally available.

In addition, where automatic door closers are used, a minimum 12" clearance is also required at the latch *push* side.

9. SHORT TERM BUILDING IMPROVEMENTS
 - a. Door Clearances – furniture interference
Remove or relocate furniture to allow 18" clear at the latch-pull side of doors, plus 12" clear at the latch *push* side where the door is equipped with a closer.
 - b. Maintenance and Repair
Repair drinking fountain.
Insulate hot water piping under Men's Room lavatory.

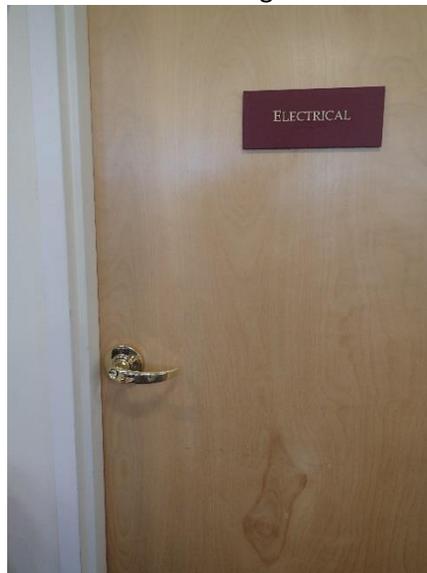
- Lack of tactile warning at doors to hazardous locations.

10. LONG TERM BUILDING IMPROVEMENTS
 - a. Door Hardware –
Provide tactile warning on backside of handle at doors to hazardous locations.

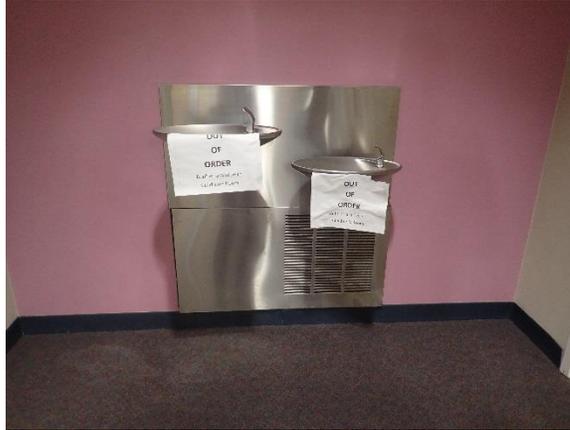
- iv. **Water Fountain not operational**
This was presumably a temporary condition at the time of our visit. Alternate accommodation in the Children's area was available.

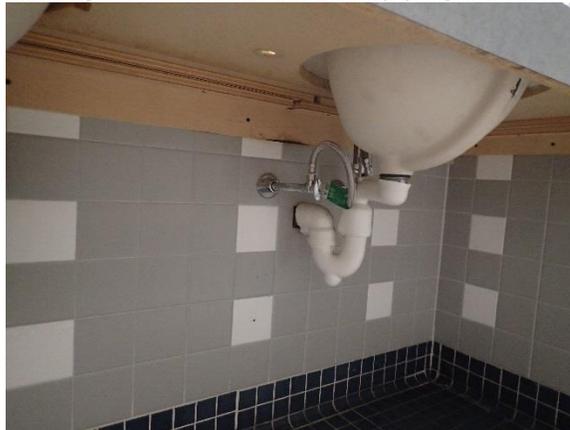
Missing insulation at hot-water piping below lavatory, Men's room:

This may have been the result of an incomplete repair and was pointed out to Library staff.
